# HIGH VOLTAGE BUSHING: DESIGN, APPLICATION AND DIAGNOSIS FOR TRANSFORMER RELIABILITY

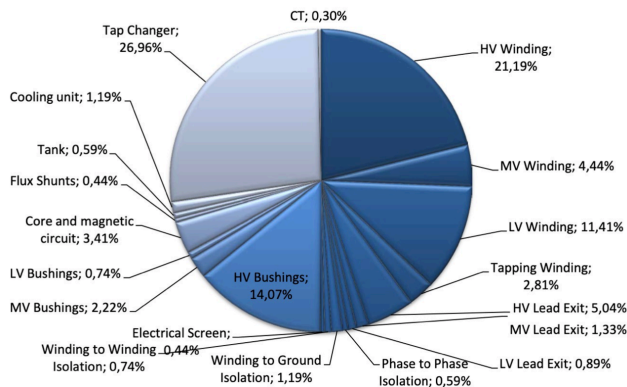
Reliability survey of transformer component failure. 17% caused by bushing failure. (Source: CIGRE TB642:2015 - Transformer Reliability Survey)

A failure of transformer bushing sometimes resulting in transformer failure which can incur additional costs, much higher than the cost of the failed bushing and lead to downtime of the transformer. A statistical reliability survey published by CIGRE indicates that 17% of power transformer breakdown caused by bushing failure. Moreover,

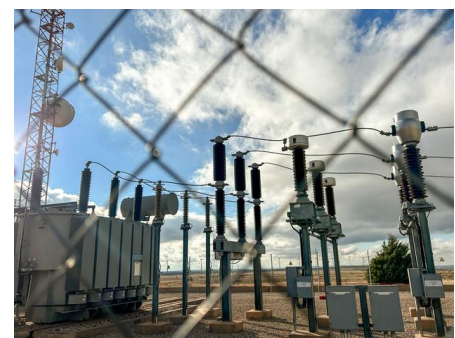
Installation of lightning arrester at transformer bushing

Transformer installed closed to high voltage breakers or disconnecting switches, which are frequently being operated are subjected to electrical switching transients. Depending on the distance and how the transformers are connected to the breakers/disconnect switches, the impact can be significant. The energy introduced by Very Fast Transients (VFT), Lightning Transients and Switching Transients in the network will results in short term overvoltage and risk into bushing operation. Nevertheless, long overhead line and cable connection will provide high impedance and high capacitance, which will attenuate the wave and minimize the impact. Further, the maximum amplitude of transients can be effectively controlled by using surge arrestors.

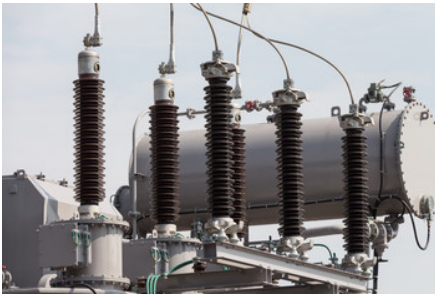
Mechanical forces can destroy transformer bushing

The overhead line and cable connection connected to air part of the bushing introduced vertical and horizontal forces. The changing load current of an overhead line will result in different temperatures of the wire conductor itself and result in a different quasi-static mechanical force. Transient mechanical forces can also be introduced by wind and through-faults. This excessive mechanical forces can mechanically destroy a bushing. The quasi-static forces and the transient force do have the potential to weaken the sealing system of bushings and would lead to moisture ingress.
