CORROSIVE SULPHUR IN TRANSFORMER: A SERIOUS PROBLEM?

TRANSFORMER FAILURE BY CORROSIVE SULPHUR

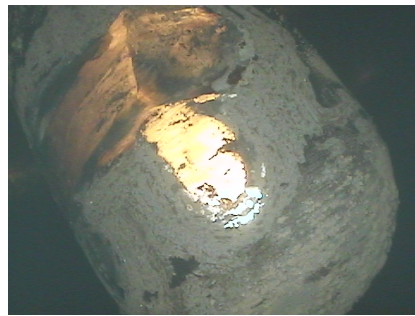
Flake of sulphur sulphide at tap changer contact

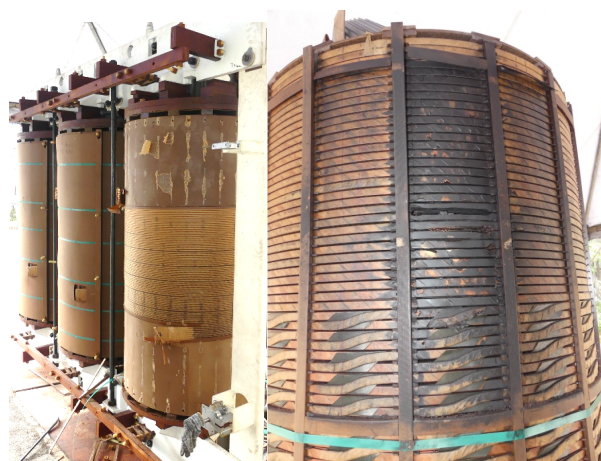
The transformer was 20 years in operation and originally supplied with inhibited oil. The transformer was tripped on bucholz relay and further analysis shows high combustible fault gases and failed on turn ratio, excitation current and sweep frequency response analysis measurement. The oil quality analysis indicated high DBDS content. The transformer was dismantled and un-tank and the winding was inspected for fault identification. The internal inspection shows inter-turn fault on one phase of the transformer windings.

Internal inspection of transformer winding shows inter-turn fault

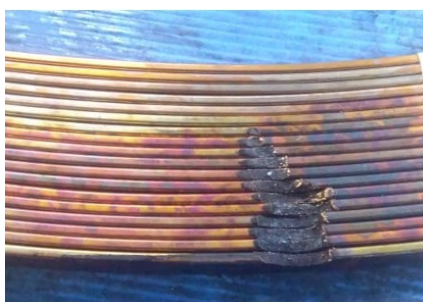
The teardown examination revealed a copper corrosion sign in which a discoloration or rainbow colour and black mark was observed at the inner copper winding. The sulphide was also found deposited on insulation paper and this is one of the factors that has reduced the dielectric strength of kraft paper and eventually short circuited the winding conductor.

Short circuit of winding conductor
