EDITION 2/2021 - ISSUE 3

TAP CHANGER: DESIGN, OPERATION & MAINTENANCE AND MONITORING (PART 2)

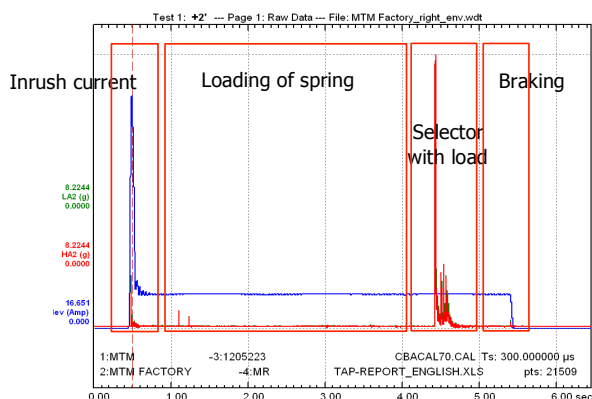
Relation of motor current and vibration signature with tap changer operation

The analysis of the signature requires an in-depth understanding of each significant tap changer event and its acoustics counterpart. A series of mechanical and electrical events produce distinctive vibration and noise patterns. Listening to these vibration and detecting any changes in time may indicate a developing of tap changer malfunctions or wears.
